DEPARTMENT OF TRANSPORTATION**DIVISION OF ENGINEERING SERVICES**

Quality Assurance and Source Inspection

Contract #: 04-0120F4Cty: SF/ALA Rte: 80 PM: 13.2/13.9File #: 69.28**WELDING INSPECTION REPORT****Resident Engineer:**Siegenthaler, Peter**Address:** 333 Burma Road**City:** Oakland, CA 94607**Report No:** WIR-019673**Date Inspected:** 13-Jan-2011**Project Name:** SAS Superstructure**OSM Arrival Time:** 700**Prime Contractor:** American Bridge/Fluor Enterprises, a JV**OSM Departure Time:** 1900**Contractor:** Zhenhua Port Machinery Company, Ltd (ZPMC), Changxing Island **Location:** Shanghai, China**CWI Name:** Mr.Zhu Zhong Hai.**CWI Present:** Yes No**Inspected CWI report:** Yes No N/A**Rod Oven in Use:** Yes No N/A**Electrode to specification:** Yes No N/A**Weld Procedures Followed:** Yes No N/A**Qualified Welders:** Yes No N/A**Verified Joint Fit-up:** Yes No N/A**Approved Drawings:** Yes No N/A**Approved WPS:** Yes No N/A**Delayed / Cancelled:** Yes No N/A**Bridge No:** 34-0006**Component:** Tower and Orthotropic Box Girder (OBG)**Summary of Items Observed:**

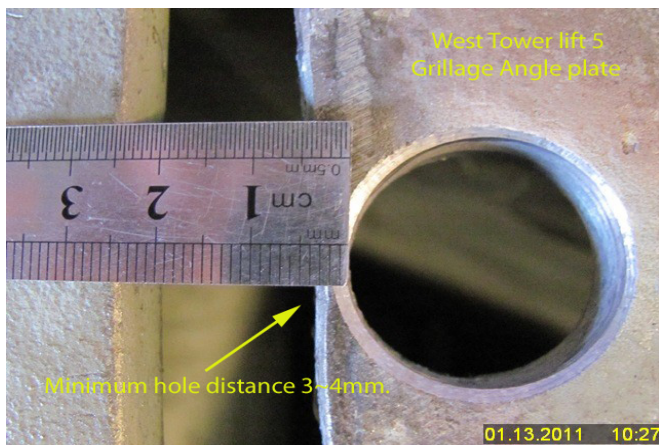
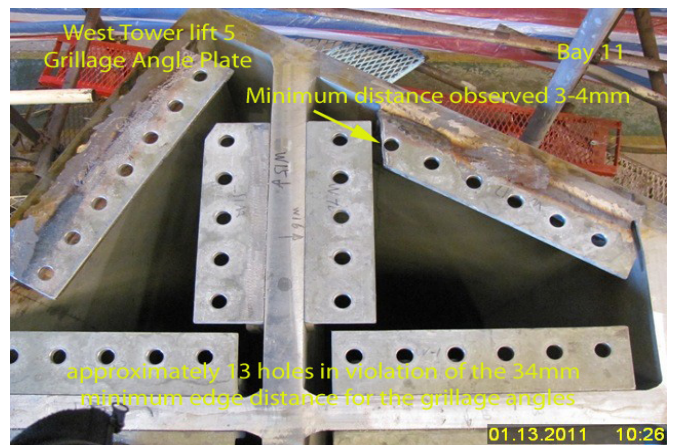
This QA Inspector observed in Bay 11 on Tower lift 5 West, North, East and South approximately 13 holes in violation of the 34mm minimum edge distance for the grillage angles minimum distance observed 3~4mm. For more information see below attached picture.
